PB90-916405
NTSB/MAR-90/04

NATIONAL TRANSPORTATION SAFETY BOARD

MARINE ACCIDENT REPORT

GROUNDING OF
THE U.S. TANKSHIP EXXON VALDEZ
ON BLIGH REEF, PRINCE WILLIAM SOUND
NEAR VALDEZ, ALASKA
MARCH 24, 1989

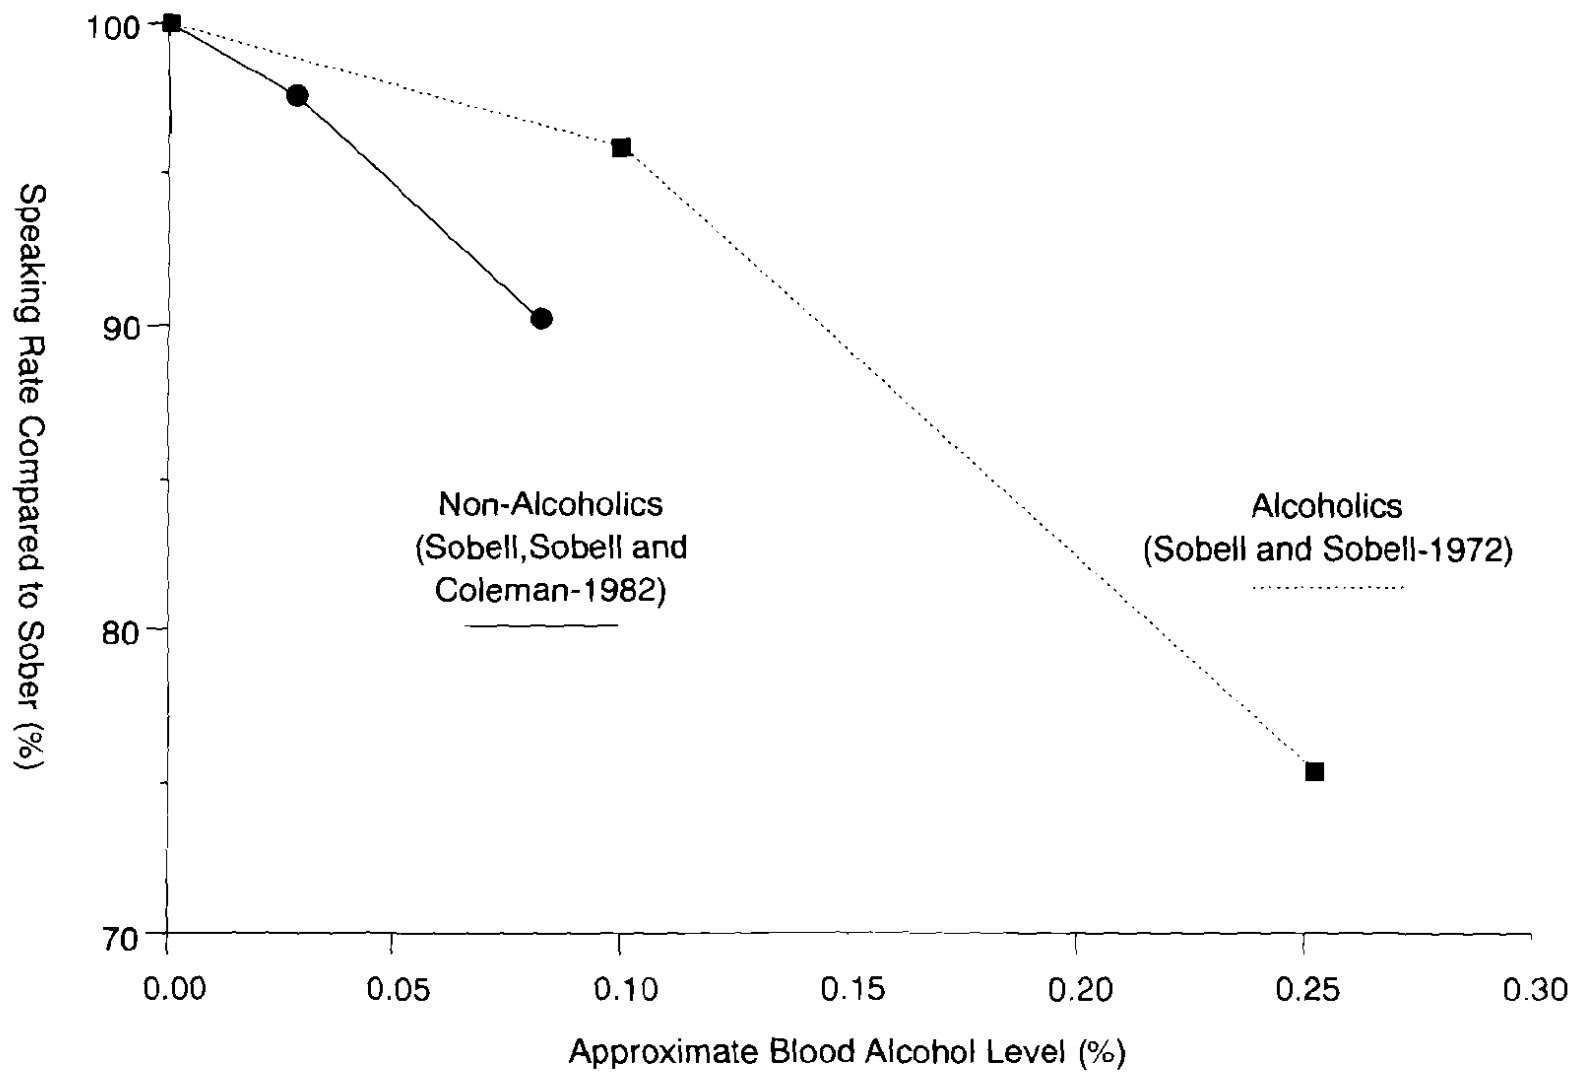
Figure 14.--Speaking rate changes with blood alcohol level.

speech 9 hours after the accident and that it was significantly slower than his speech 33 hours before the accident.

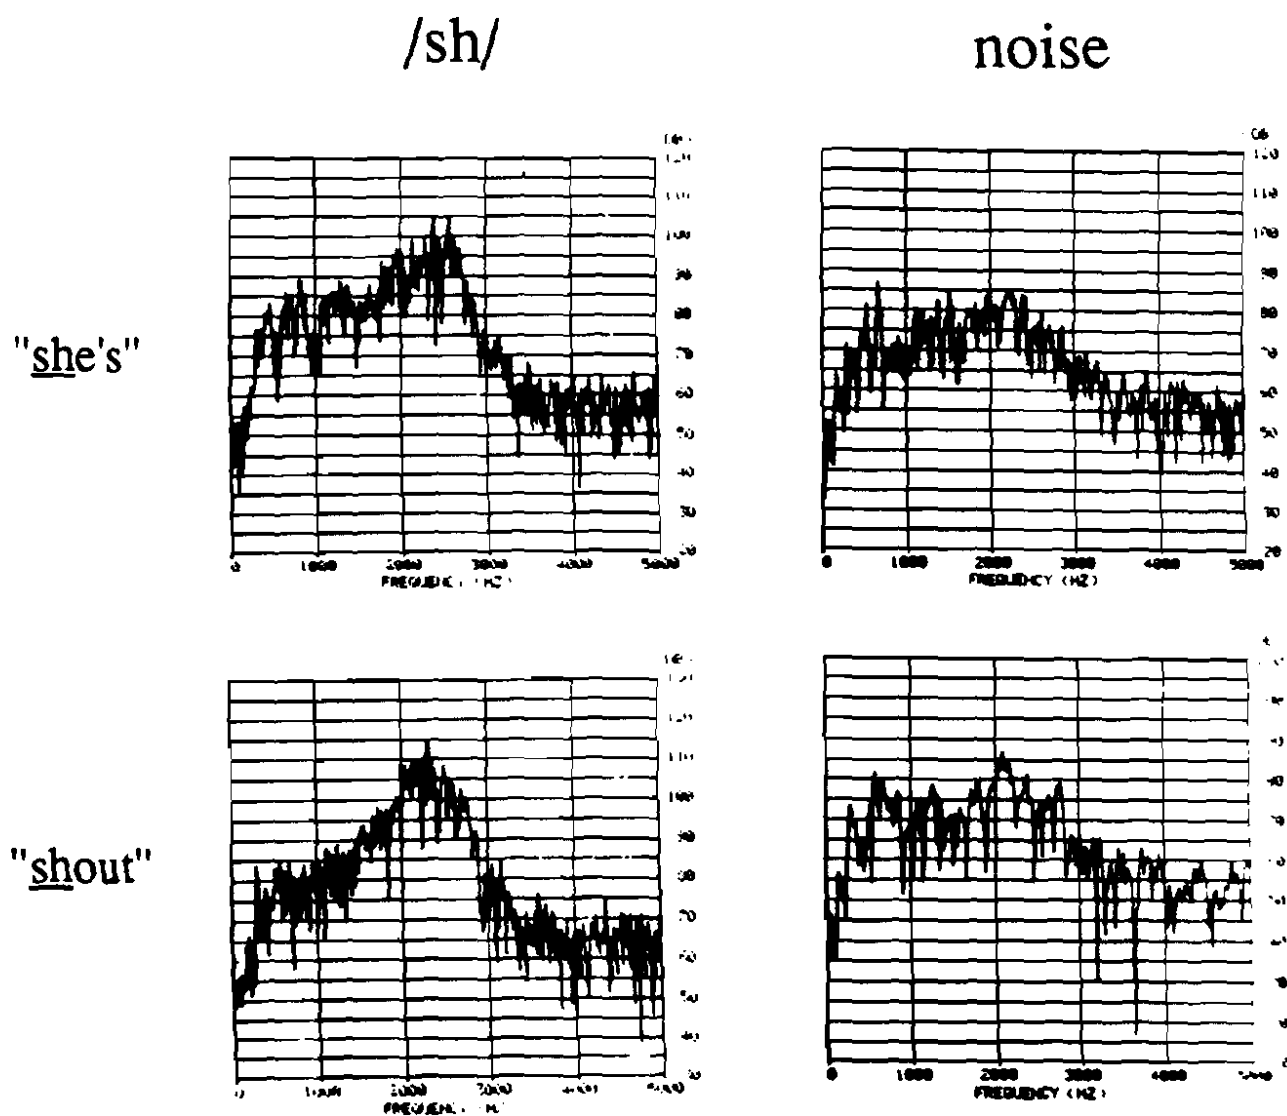
Figure 2. Power spectra of /sh/ produced by Captain Hazelwood in the words *she's* and *shout* recorded 33 hours before the accident. Each spectrum is paired with a spectrum of the background noise from a nearby open-mike pause.

Figure 2 shows power spectra of the /sh/s of *shout* and *she's* (and spectra of background noise near the fricative) as spoken by Captain Hazelwood in the recording made 33 hours before the accident. The spectra in Figure 2 give an indication of what this speaker's /sh/ will look like in this type of display. The lower amplitude peak between 2000 to 3000 Hz, illustrated in Figure 1, is present in the spectra in Figure 2, but the higher frequency information which would serve as the most reliable information distinguishing /s/ and /sh/ is not present in these spectra because the radio transmission equipment was band limited at 3000 Hz⁷. In making these comparisons, we had to be concerned also about the spectral shape of the background noise in the NTSB recordings. The spectra in Figure 1 were calculated from recordings made in a quiet recording booth, while the NTSB recordings have background noise which may be confused with fricative noise. Therefore, paired with each fricative spectrum from the recordings, we also show a spectrum of nearby background noise as a baseline against which the fricative spectrum can be compared.

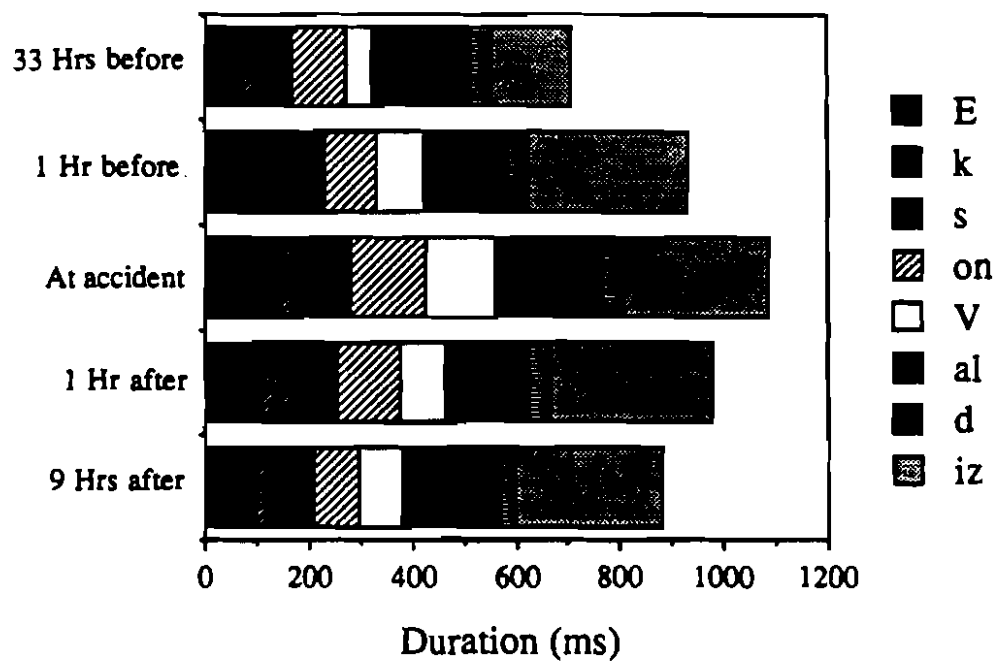
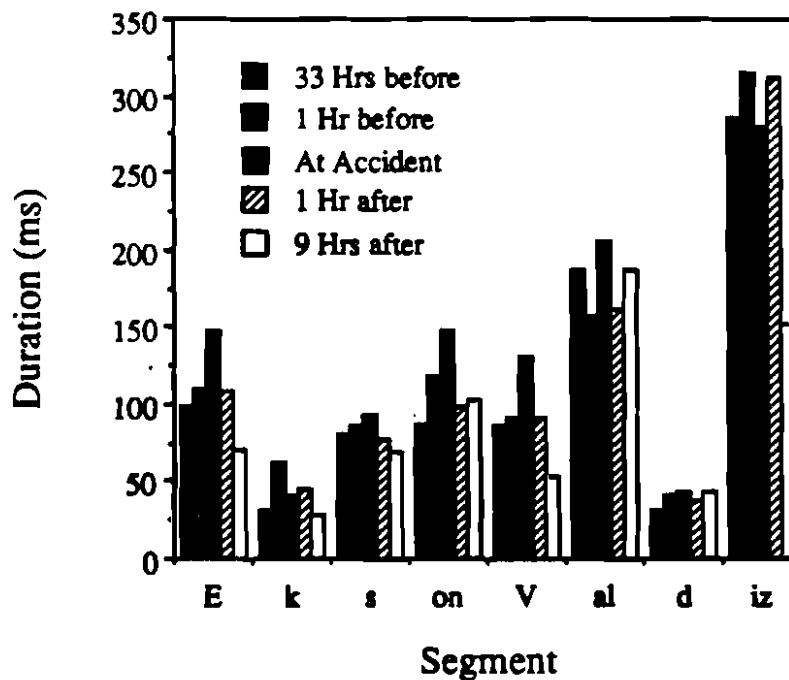
Durational changes are perhaps the most reliable effects we have found in the NTSB recordings and they suggest that Captain Hazelwood was speaking more slowly than normal around the time of the accident. These changes in duration are consistent with the laboratory
